Fairlington Meadows

April 4, 2023 • Arlington, VA

Fairlington Meadows Arlington, Virginia

At the direction of the Board that recognizes the need for proper reserve planning, we have conducted a *Full Reserve Study* of Fairlington Meadows in Arlington, Virginia and submit our findings in this report. The effective date of this study is the date of our visual, noninvasive inspection, April 4, 2023.

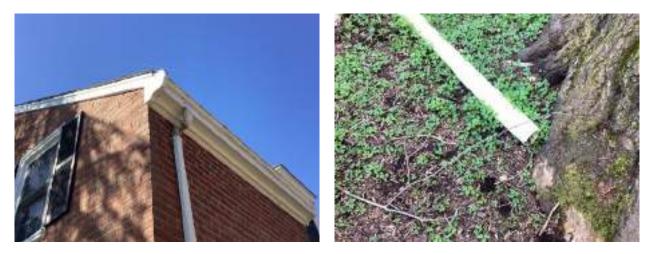
Condition: Good to fair overall with isolated dented sections evident.

Dented downspout

Component Detail Notes: The size of the gutter is determined by the roof's watershed area, a roof pitch factor and the rainfall intensity number of the Association's region. We recommend sloping gutters 1/16 inch per linear foot and providing fasteners a maximum of every three feet.

Downspouts can drain 100 square feet of roof area per one square inch of downspout cross sectional area. We recommend the use of downspout extensions and splash blocks at the downspout discharge to direct storm water away from the foundations.

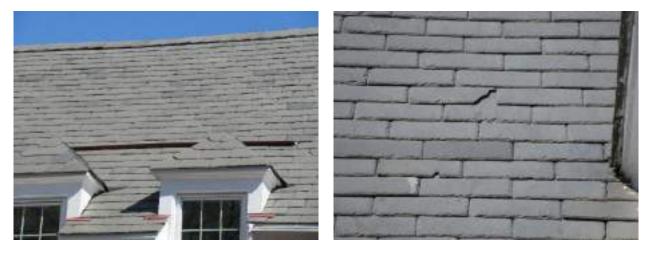
Condition: Varies from good to fair overall with missing shingles, previous repairs, flashing deterioration, shingle deterioration, organic growth and shingle lift evident from our visual inspection from the ground. Management and the Board report a limited history of leaks.

Damaged shingles

Shingle deterioration

Component Detail Notes: The occurrence of roof leaks will increase as more slate shingles crack, break and dislodge. As the shingles age they will begin flaking about their edges or delaminating followed by the occurrences of broken or dislodged shingles. This deterioration will result in increased maintenance costs such that replacement becomes the least costly long-term alternative as compared to ongoing repairs.

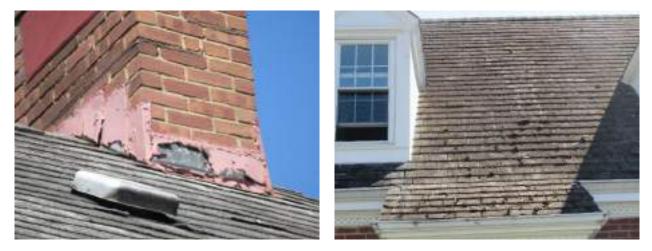
Flashing deterioration

Organic growth

Preventative Maintenance Notes: We recommend the Association maintain a service and inspection contract with a qualified professional and record all documentation of repairs conducted. We note the following select recommended preventative maintenance activities to maximize the remaining useful life:

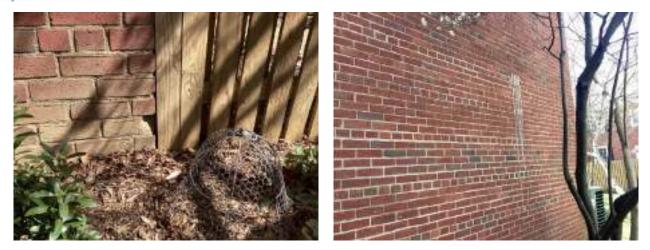
- Efflorescence is visible (Efflorescence is not a safety concern. However, it can be an indication of water infiltration, masonry saturation, improper drainage behind the façade or another underlying issue.)
- Masonry exhibits cracks
- Masonry exhibits spalls
- Mortar deterioration is evident

Masonry spall

Efflorescence

Repointing is a process of raking and cutting out defective mortar to a depth of not less than ½ inch nor more than ¾ inch and replacing it with new mortar. Face grouting is the process of placing mortar over top of the existing mortar. We advise against face grouting because the existing, often deteriorated mortar does not provide a solid base for the new mortar. New mortar spalls at face grouted areas will likely occur. One purpose of a mortar joint is to protect the masonry by relieving stresses within the wall caused by expansion, contraction, moisture migration and settlement. Repointed mortar joints are more effective if the mortar is softer and more permeable than the masonry units, and no harder or less permeable than the existing mortar. The masonry contractor should address these issues within the proposed scope of work. The following diagram details a typical masonry façade system and may not reflect the actual configuration at the Association:

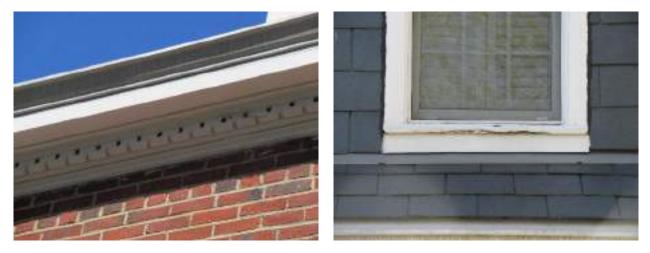
Condition: Fair overall with trim damage and deterioration evident.

Trim deterioration

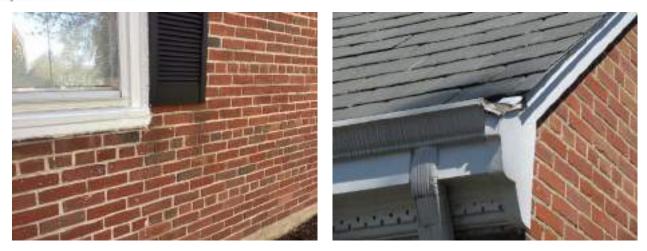
Trim deterioration

Trim damage

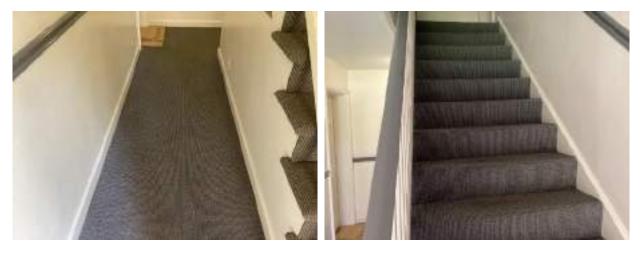
Condition: Good to fair overall with isolated stains evident

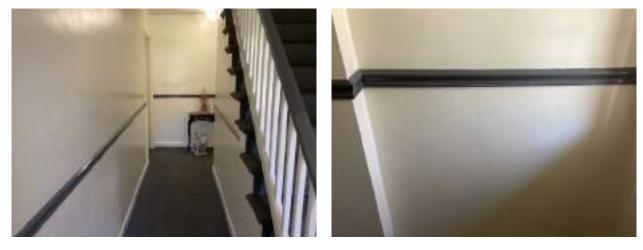
Condition: Fair overall isolated scuffs evident

Wall scuffs

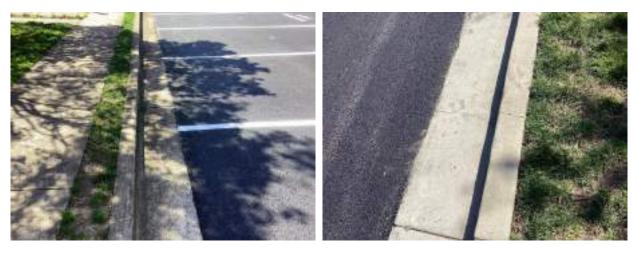
Condition: Good to fair overall with cracks and spalled concrete evident.

Concrete cracks

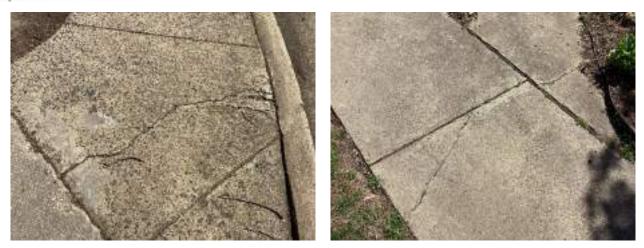
Sidewalk cracks

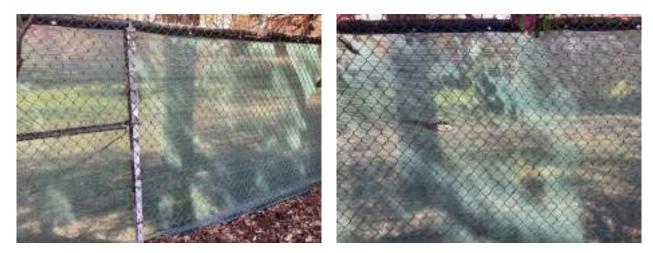
Condition: Good to fair overall with isolated fabric tears evident

Chain link fence - Note fabric tear

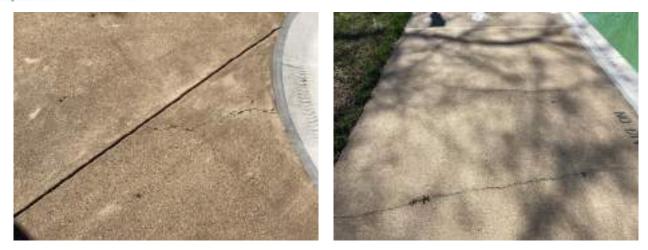
Condition: Fair overall with periodic cracks evident.

Concrete cracks

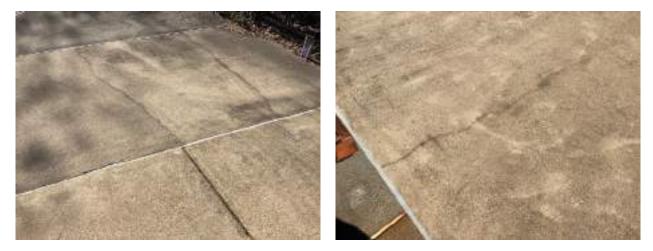
Concrete cracks
